To APE or not to APE? Case Series and Novel Technique of Arthroscopic Polyethylene Exchange for Metal-Backed Glenoids in Total Shoulder Arthroplasty

¹Department of Orthopaedic Surgery,
University of Pennsylvania,
Philadelphia, PA

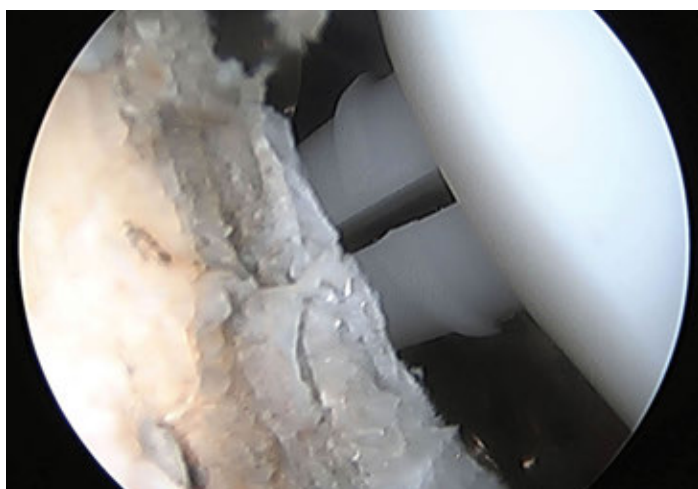
Figure 2. The new polyethylene liner is inserted through the anterior portal, rotated to the correct orientation, and snapped into place using a Cobb elevator.

The anterior incision is then extended approximately 2 centimeters to allow for space for the implant. A radiofrequency ablation device can also be used to open the rotator interval to allow for ease of removal. An arthroscopic grasper is then used to remove the polyethylene from the shoulder. The new polyethylene implant is then inserted through the extended anterior portal (Figure 2). An arthroscopic probe is used to rotate the implant to the appropriate orientation (Figure 3). A Cobb elevator is then reintroduced through the anterior portal and medial pressure is applied to click the polyethylene into the metal baseplate. The elevator can then be used to gently try to elevate the polyethylene to ensure it is fully docked. The camera can also be moved to the anterior portal to visually confirm complete seating. Arthroscopic fluid can then be evacuated from the shoulder, and the portals closed.

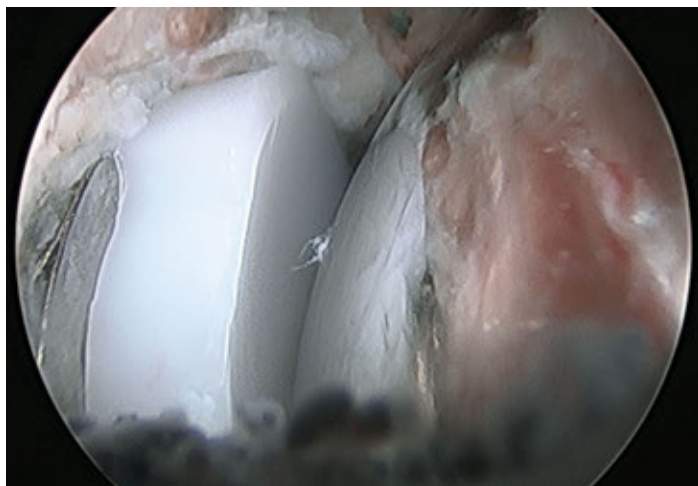
Figure 3. The scope can be used from the posterior and anterior portals to confirm complete seating of the liner.

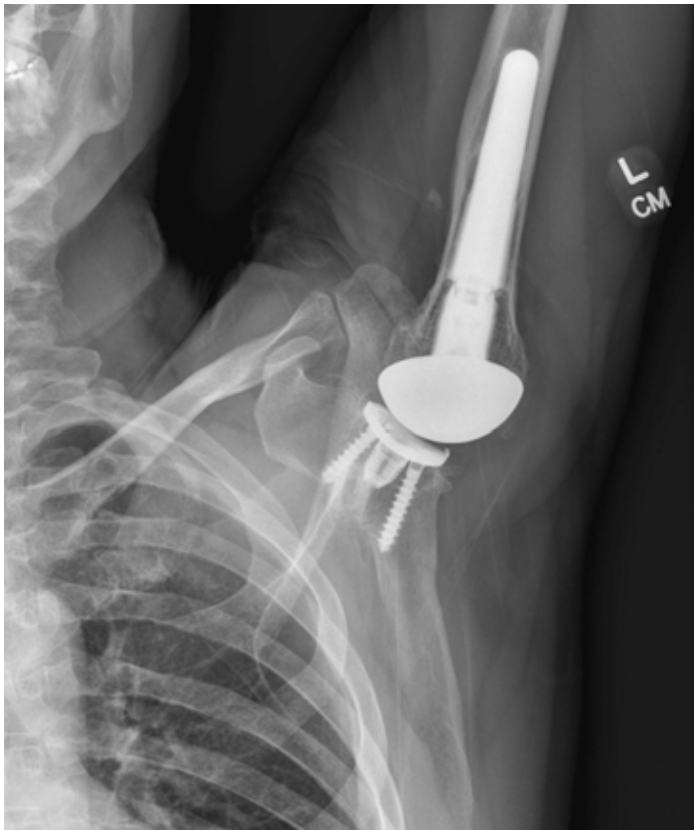
Figure 9. Axillary radiograph showing restoration of joint space, as well as appropriate rotator cuff balance, with the humeral head well-centered in the glenoid.
